# Train Rail Ultrasonic Inspection Systems

*SFB-100* SERIES RAIL INSPECTOR

*State-of-the-art ultrasonic inspection systems for high-speed flaw detection, evaluation and documentation for train rails*

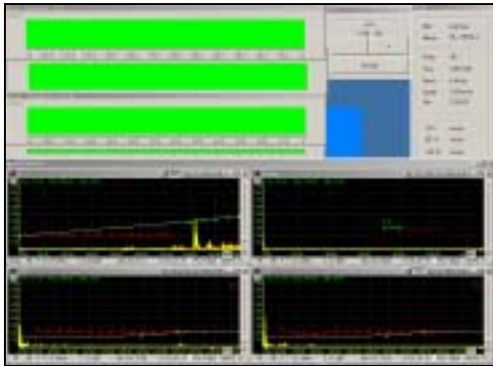
UT display – left hand side rail

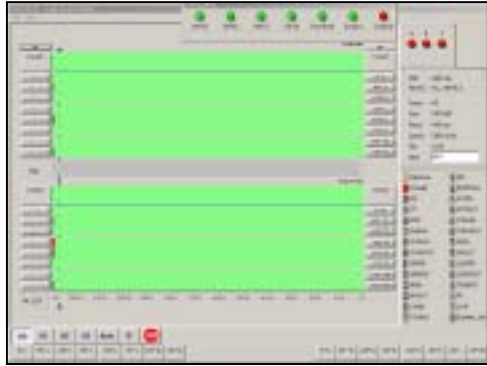
Running B-scan

<b>Real-time B-scan display</b>	<b>ScanMaster</b> software-generated longitudinal B-scan of rail provides a real-time image of indications for each ultrasonic channel.
<b>Operator control console</b>	Includes TFT display monitor for system operation and ultrasonic signal display, keyboard and control mouse.
<b>Data storage and evaluation of indications</b>	On-line storage of scan data for each active channel. Data evaluation can be on- or off-line, based on pattern recognition of single or composite longitudinal B-scan images of indications. Fully documented inspection results with the capability for advanced flaw evaluation based on digital pattern recognition of longitudinal B-scan cross-sections.
<b>Real-time detection</b>	Real-time detection of defects and paint marking.
<b>Number of inspection channels</b>	Up to 12 ultrasonic channels per rail. Simultaneous firing of all channels.
<b>Maximum inspection speed</b>	Up to 100km/hr (60miles/hr), dependent on longitudinal resolution requirement and performance of ultrasonic coupling device.

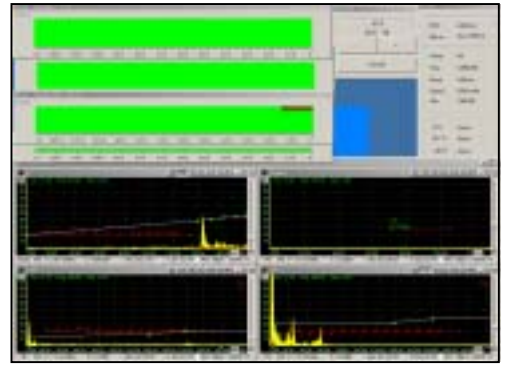
UT display – right hand side rail

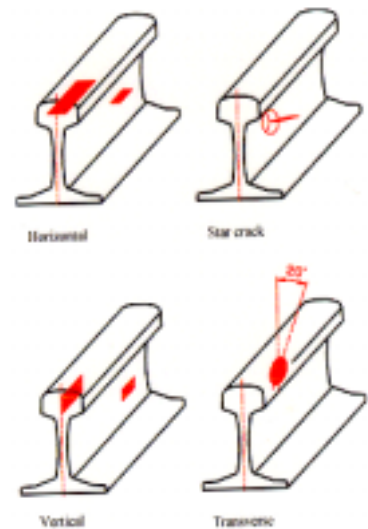
Flaw evaluation
